# PAINTER-LEWIS, P.L.C.

July 24, 2015

Re: Asbury Church 105 North Jay Street Middleburg, Virginia Structural Evaluation

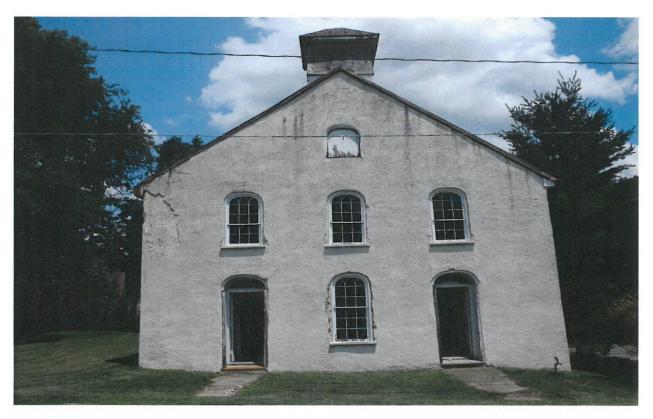
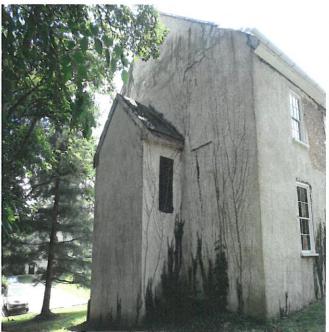
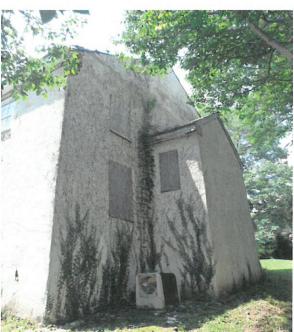
Pictures #1 - #3: Exterior: Pictures showing the exterior finishes and an overview of the conditions at the front (western) and rear (eastern) elevations of the church.

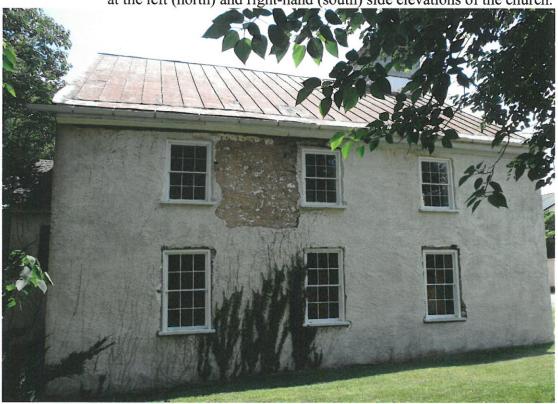
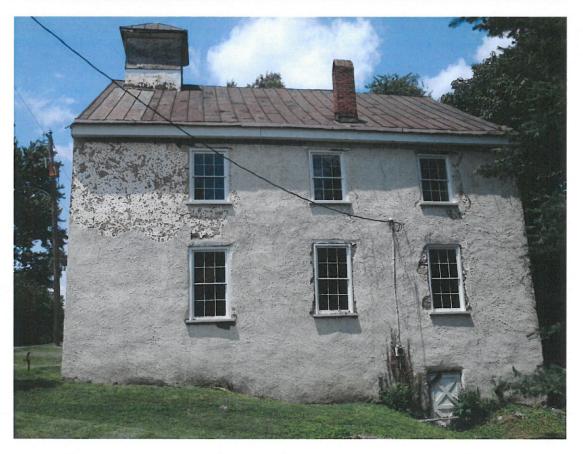
Pictures #4 - #5: Exterior: Pictures showing the exterior finishes and overview of conditions at the left (north) and right-hand (south) side elevations of the church.

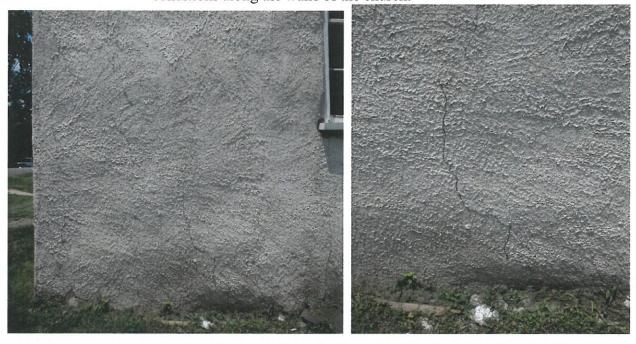
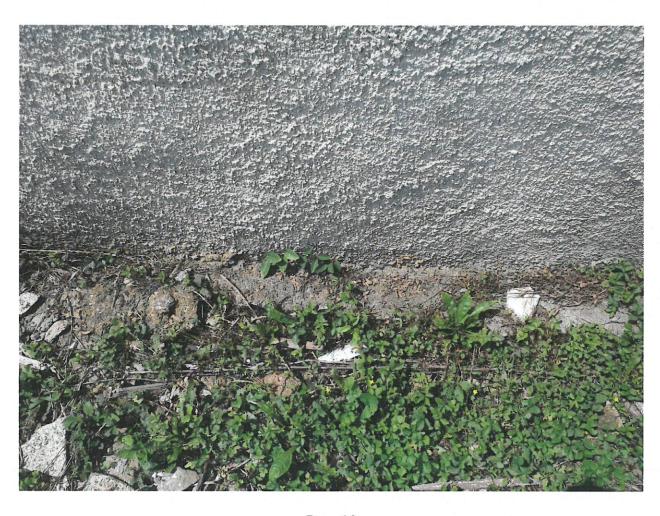
**Pictures #6 - #8:** Exterior: Pictures showing the exterior finishes and overview of the conditions along the walls of the church.

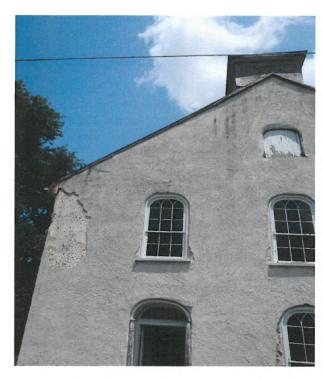
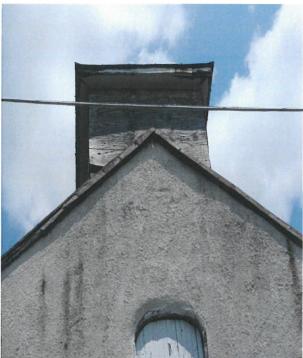
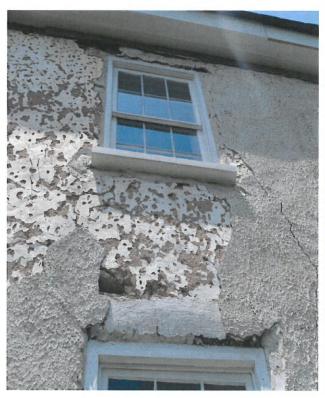
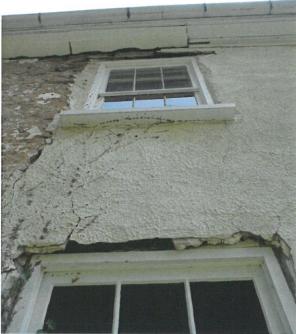
- At the time of this inspection, the exterior wall system was found to be reasonably square and plumb. Portions of the stucco finish were missing at various locations around the building. There was some cracking observed in the stucco finish and small portions of the base wall stone and mortar were visible and able to be observed. A portion of the northern and southern walls and a majority of the eastern wall had remnants of old vegetation that were dried and still adhering to the stucco finish. The northern and eastern walls had some new vegetative growth on them, as well. The eastern wall had two areas where the stucco finish was buckled and had pulled away from the wall. This may have been caused by movement in the base wall components where the stones and mortar had separated and shifted. At multiple window locations, the stucco was missing from around the window openings, cracking had developed above and around the windows, and the wood lintels had been exposed above the windows. In most cases, the wood lintels exhibited severe damage due to water infiltration, pest infestation, and were deteriorated such that they were not functioning properly.

**Pictures #9 - #12:** Exterior: Pictures showing some typical areas of water infiltration that were noted around the elevations of this church.

The exterior stucco finish and the interior pargetting is cracked and portions are missing in many locations due to water infiltration. At this time, the windows should be boarded shut and properly flashed to prevent any further water infiltration and damage to the surrounding structural elements. At the time of the full renovation of this building, the windows should be removed, repaired, and properly reinstalled; or new windows should be installed to replace the existing ones. New lintels, proper frame work, and the necessary flashing can be installed during the future restoration phase of construction.

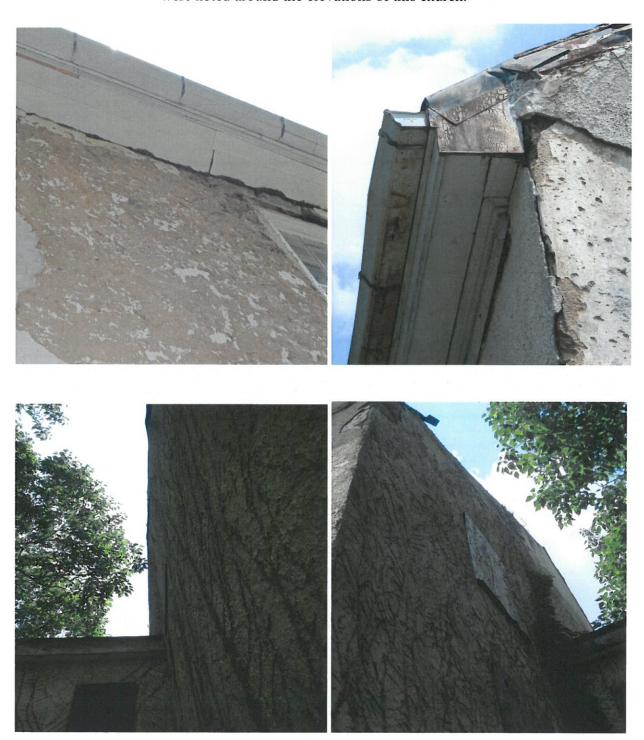
**Pictures #13 - #16:** Exterior: Pictures showing some typical areas of water infiltration that were noted around the elevations of this church.

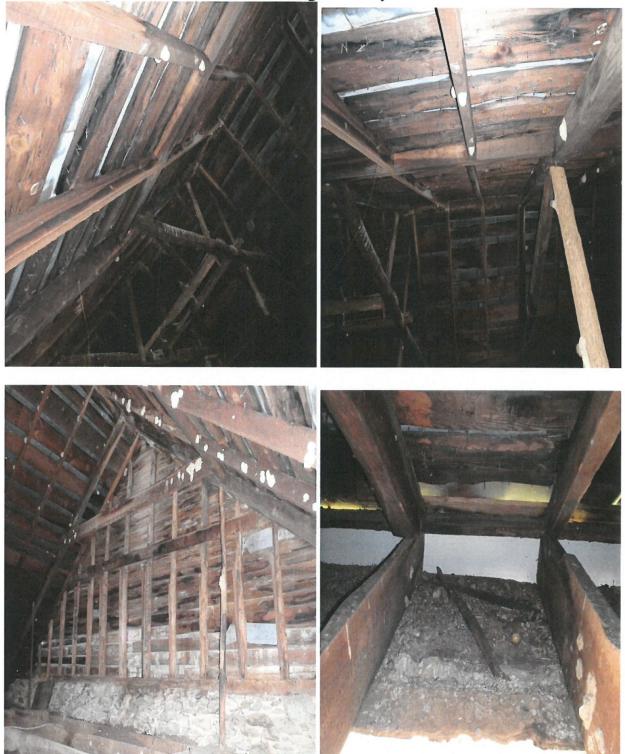
- The roofing system consists of a standing seam metal roof that is installed onto variable width 1"x wood skipped sheathing. The structural system appears relatively sound and functioning satisfactorily. There are areas of deterioration and water damage that should be corrected, but generally the wood structure appears relatively sound. No structural analyses were done of this system or the individual structural components as part of this scope of work. Prior to further occupancy, it is recommended that this system be fully analyzed and reinforced for future use. At this phase,

- As stated, the roofing system is a standing seam metal roofing system. There are many areas of deterioration and rust that were observed throughout this system. Additionally, there are "pinholes" throughout this roofing system, as well. Exterior light could be seen through very small punctures in the metal roofing at multiple locations. Approximately 12" eaves exist on the sides of this roofing system which project beyond the side perimeter walls. This helps to convey the roof water away from the main side walls and roofing structure; but, there is extensive deterioration in these eaves and severe water infiltration is evident. No eaves or even small roof extensions exist on the gable ends that would help to protect the gable end walls. Water infiltration is occurring along the roof and wall interface resulting in damage to the structural systems on these gable ends. The lack of a proper gutter and downspout system is contributing to the water infiltration and resulting damage, as well. This must be corrected as part of the stabilization phase of this building so further deterioration does not continue.

Pictures #17- #20: Interior: Pictures showing the roof system of the church.

the damaged elements should be reinforced and the water infiltration should be eliminated to ensure that the structural integrity of this system is maintained until a future use is determined.

- The roofing system is in need of substantial repairs. There are no eaves on the gable ends and the side wall eaves are severely deteriorated. Water infiltration along the gable ends and through the eaves is clearly evident and must be addressed immediately to ensure that no additional damage occurs to the structural components and systems. It is recommended that at a minimum, the roofing system should be fully covered or repaired to prevent any further water infiltration. A roofing contractor should be contacted to fully review this system and to make recommendations for its temporary repairs. At the future phase of the complete renovation for a specific use, the structural elements must be repaired, reinforced, and extended, as needed, to ensure that the roofing system will function properly. Additionally, a new standing seam metal roofing system should be installed at that time.

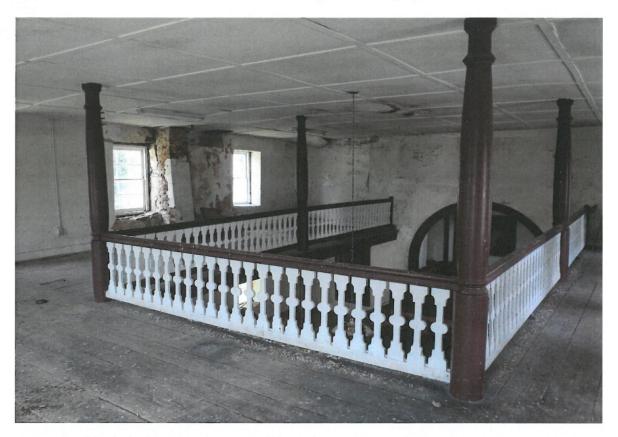
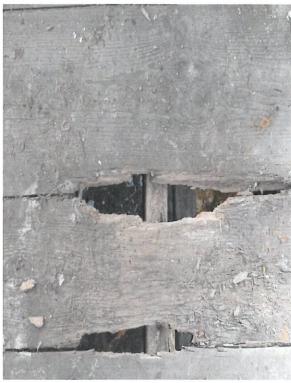
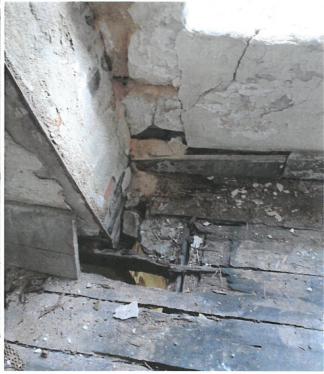
- This former church structure has a U-shaped balcony around what was the sanctuary area of the building. As stated previously, the balcony floor joists consist of 1.75"x8.5" rough-cut floor joists spaced at approximately 24" o.c. The sheathing consists of 1"x variable width wood floor boards. This floor system is supported by the exterior stone walls and an interior perimeter beam and column system. The wood beams consist of 6"x10" rough-cut timbers that are supported by the approximately eight inch (8") diameter wood columns which have been milled to six inches (6") at various segments throughout the column lengths. There were several areas of this balcony floor system that were subjected to water infiltration. Areas where the wood sheathing and joists had been damaged, were now exposed, which permitted some limited observation to these structural components. Other than the areas where water infiltration has damaged the floor system elements, the floor joists appeared relatively sound. Similarly, the wood flooring was in satisfactory condition and there were no significant separations between the floor boards. The areas subjected to water infiltration show evidence of rot and deterioration of the wood elements and a subsequent reduction in their respective cross-sections. Typically, the damage occurred in the areas where no flashing or protection against the elements existed, such as around the chimneys and under the windows units. The water infiltration must be addressed and then the damaged elements can be repaired, reinforced, or removed and replaced, as needed. This water infiltration has resulted in damage and deterioration of the masonry chimney structures, as well.

Pictures #21- #23: Interior: Pictures showing the balcony system of the church.

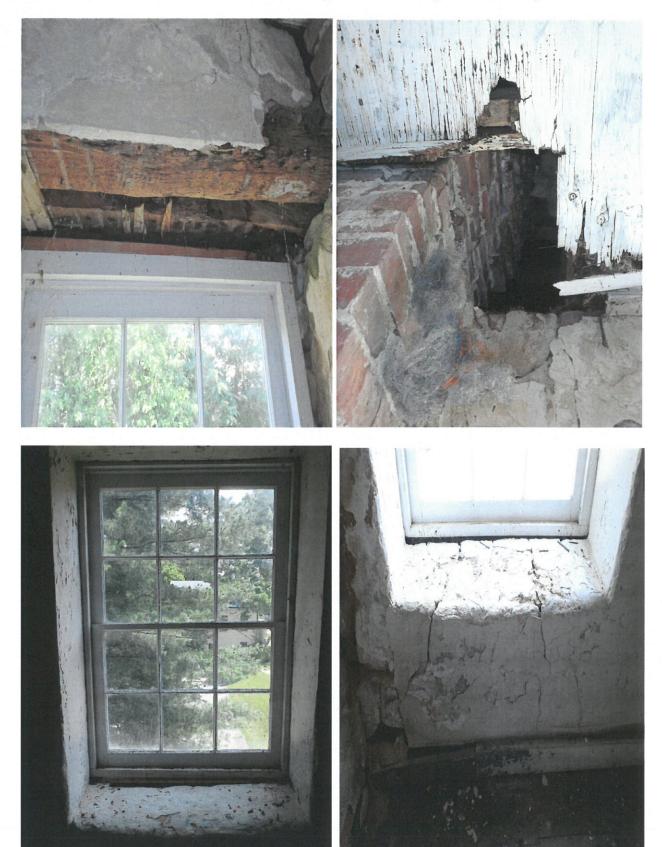
Pictures #24- #27: Interior: Pictures showing the water damage in the balcony area.

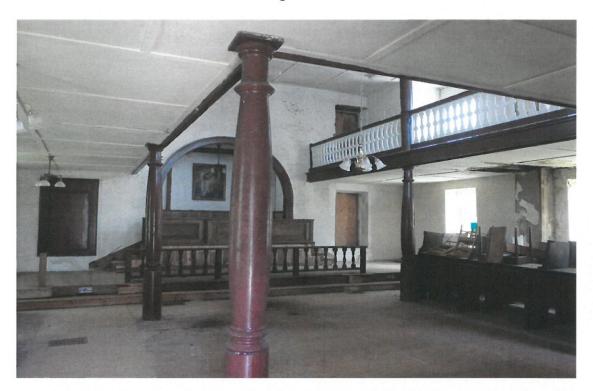
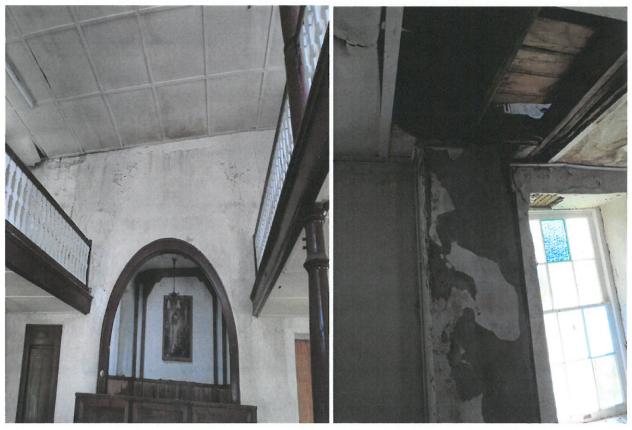
- The first floor diaphragm consists of 8"-9" diameter logs spaced at approximately 26" on center. The sheathing appears to be 1"x variable width floor boards similar to what was observed in the balcony area. This sheathing has been covered with a uniform, more modern, 1"x finished wood flooring that serves as the wearing surface of the main level.

Pictures #28- #30: Interior: Pictures showing the first floor area of the church.

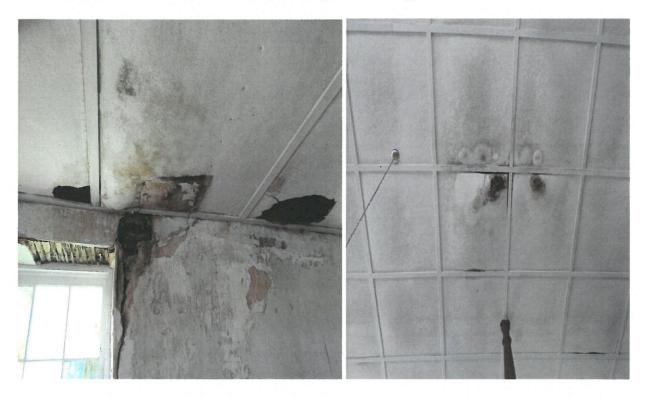
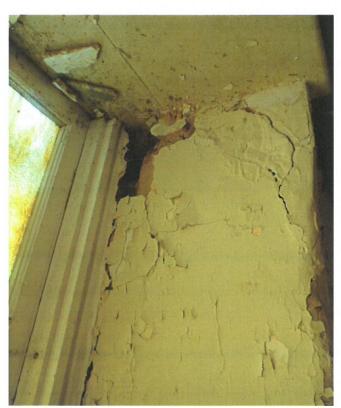
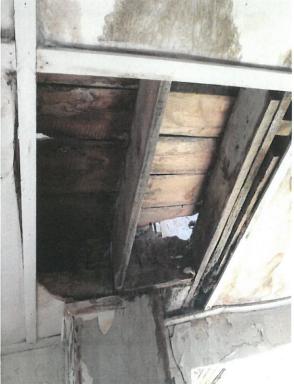
- Similar to the balcony system, there is some deterioration of the log joists where exposure to the elements exist. Additionally, the logs could be observed in the cellar area at the southeastern end of the building. These joists show some damage due to pest infestation and moisture. Not all of the joists could be observed, but it is recommended that prior to future occupancy, this floor system should be analyzed to determine its structural capacity and additional investigations should be made. For the stabilization phase of this project, these elements appear to be sound enough so that immediate reinforcement is not necessary.

Pictures #31- #34: Interior: Pictures showing water damage in the first floor level area.

- The floor systems appear sound and only the damaged members need to be repaired or reinforced at this time. There was damage, due to moisture and pest infestation, observed in the logs in the cellar area. A pest control specialist should examine this building and eliminate any infestation if still present; and make recommendations for the continued pest control maintenance around this structure. The logs should be examined more closely to determine if any repairs, reinforcement, or replacement is warranted at this time. For future use, it is recommended that a complete documentation of these elements and systems be performed which may include the need for some destructive testing. A compete analysis should be done based on the proposed use and then, the member and system repair designs can be prepared accordingly at that time.

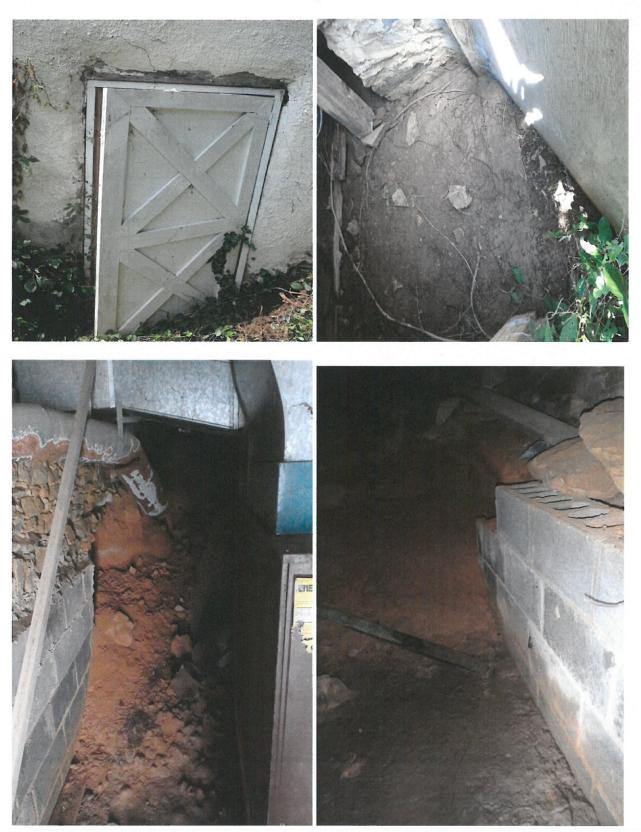
- As stated previously, this former church was built on a crawl space foundation system with a depth of approximately 36". It appears that intermediate stone cross walls were constructed to support the floor and roof systems. The crawl space has not been vented and no vapor barrier has been installed on the soil subgrade. A small cellar area has been excavated on the eastern end of the crawl space foundation system to house the heating system equipment. Small CMU foundation walls were constructed to support the crawl space stone walls and the soil backfill on the western and eastern sides of this cellar area. The southern side wall provides the access to the cellar by a shortened 36" wide exterior door. The northern, interior side of the cellar area is open and the crawl space soil floor has been sloped to the soil cellar floor. No wall has been constructed on that side. This area is very damp and mud was observed on the cellar floor at the time of these inspections. The CMU walls appear to be marginal at best to support soil subgrade and

surcharge pressure of the superstructure of the church. There were loose and missing stones in the interior crawl space walls; and large chase openings had been made to permit ducts and service utilities to penetrate the walls.

**Pictures #35- #38:** Interior: Pictures showing the cellar area of the church.

- Other than the water infiltration observed throughout this building, the cellar area is of the most concern. Water is flowing into this area, as indicated by the mud on the soil subgrade and the erosion observed on the sloped portions of the crawl space subgrade. The interior CMU walls do not appear to be adequate for this use and there are several areas where the stone walls need extensive repairs and reinforcement. During the stabilization phase of the restoration of this building, the cellar should be addressed completely to ensure that no further damage occurs in this area. A complete documentation and analysis of the wall systems should be done and the walls should be reinforced accordingly. The logs should be adequately reinforced, if needed, and properly supported for current and future use. The door into the space should be removed and replaced with a functional unit that provides entry into the space and keeps water out. If this area is intended to continue to be used for a utility room, then the existing equipment should be removed, repaired, and replaced, as needed; and a concrete floor slab should be designed and installed prior to the reinstallation of this heating system.

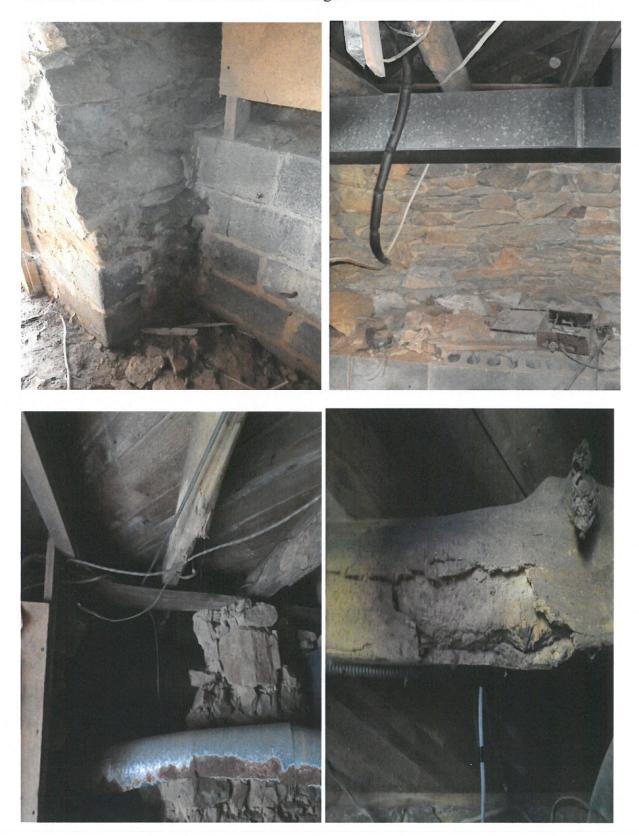
Pictures #39- #42: Interior: Pictures showing the cellar area of the church.
